## AREA: Intermediate Reheater

### P R I O R I T Y # 1 R E P A I R S

Repair #: 101-a Record:# 64

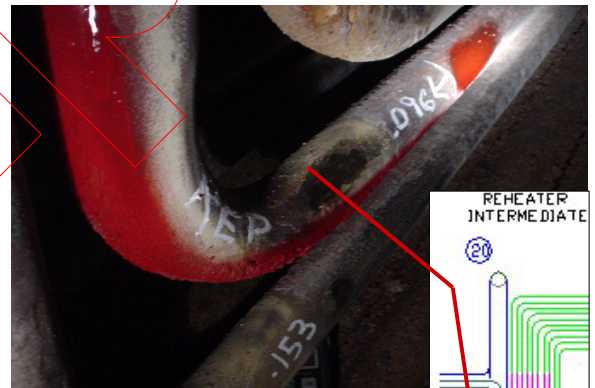
Intermediate Reheater, Leading Edge, IK-3L/3R  
Elevation: 278'

Cause: Erosion (Soot Blower)

Appearance: Eroded Tubing

Material: 2.25" OD x .165" MWT x SA-209T1A

UT Result: 0.096"

Replace tube 2 of assembly 46 to include (1) 90 degree radius bend. The tube has sustained wall loss from soot blower erosion and has a remaining wall thickness of 0.096". The cut lines will be 12" from the centerline of the radius bend on both the horizontal and vertical section of tubing.
