THE INSPECTIONEER POST

Volume 2, Issue 3

July 27, 2011

"ACID DEW-POINT CORROSION" LEADING CONTRIBUTORS AND PREVENTATIVE ACTIONS

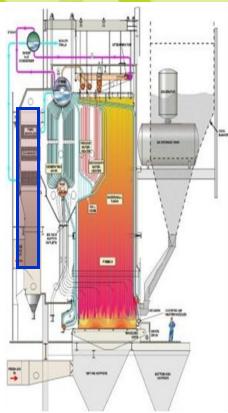
Inspection & monitoring:

Wall thickness measurements by UT methods will monitor the wastage in economizer as well other affected component tubing.

Low temperature corrosion produces tube wall thinning

exceeded. The external surface will have a gouged appearance where the corrosion activity has occurred.
